# Platform Life Extension

## SPE 124505

**Author – Brian G Hudson, ABB Engineering Services**

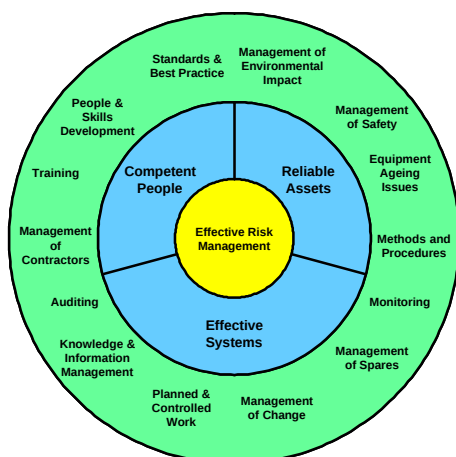
Figure 4 – The Key Elements of Effective Risk Management

Effective risk management is a wide ranging and holistic activity, as can be seen from Figure 4, which shows only a typical list of the activities and processes required to support Competent People, Reliable Assets and Effective Systems. Hence, any study or review to look at asset life extension must be comprehensive and not simply equipment focussed.

- The effectiveness of Risk Management, as shown in Figure 4.
- The integrity of the equipment
